**2007 Operations, Maintenance,
and Monitoring Report**

**Vermilion River Cutoff Bank
Protection**

State Project Number TV-03
Priority Project List 1

August 2007
Vermilion Parish

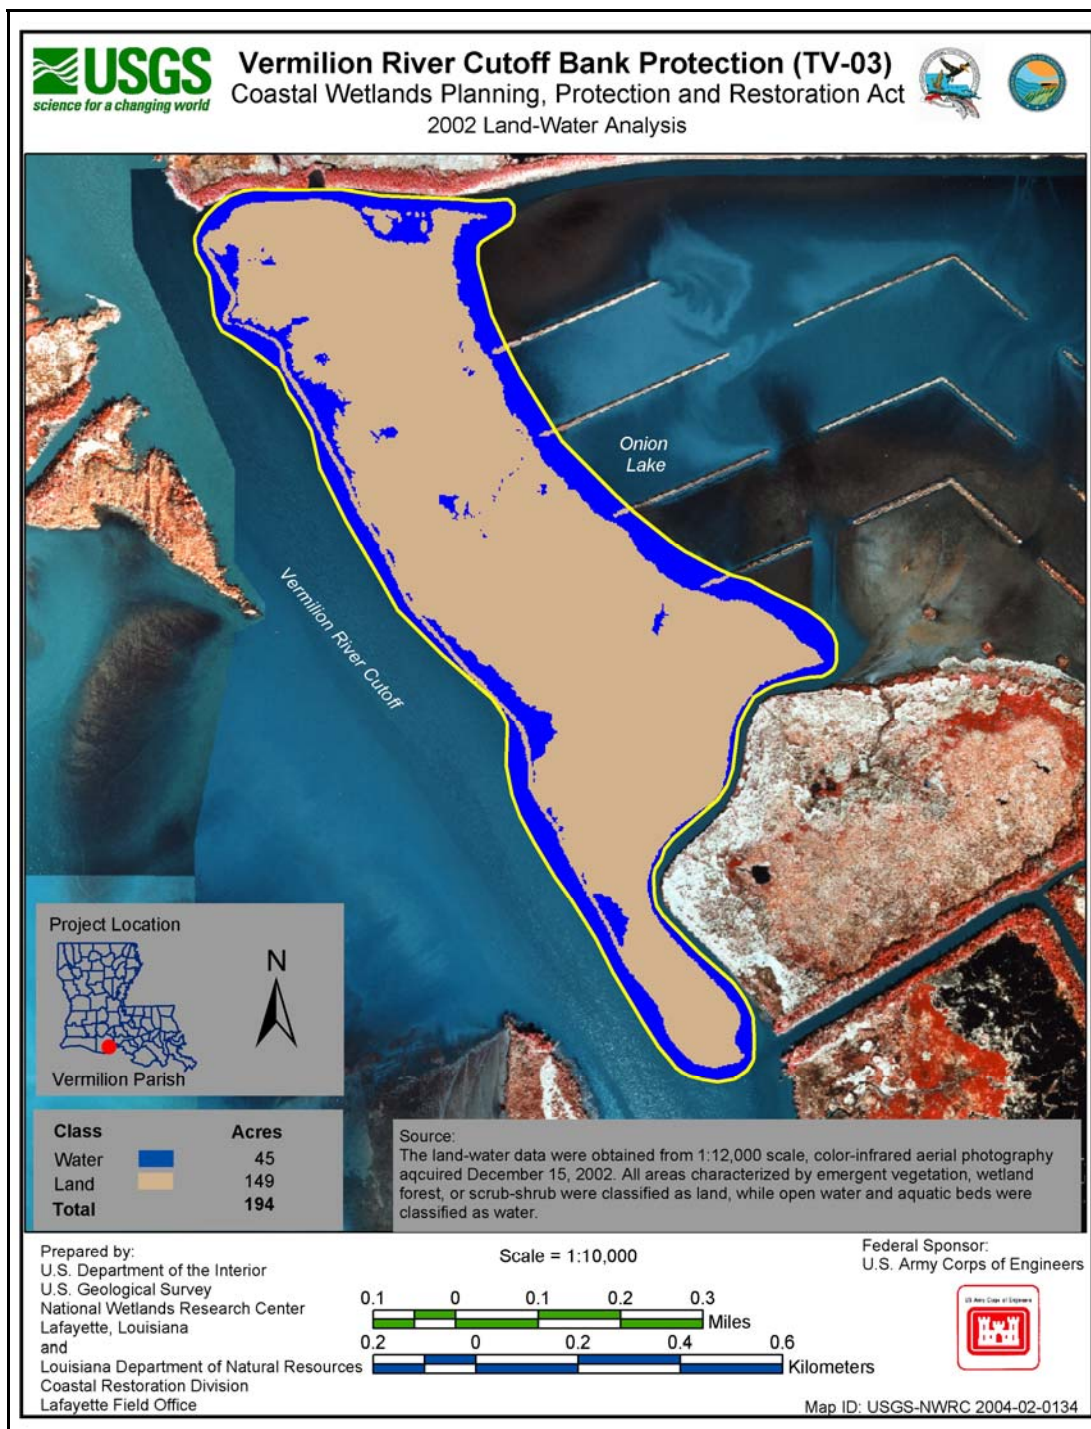
Figure 3. Land to water analysis for Vermilion River Cutoff Bank Protection (TV-03) project area in 2002.

Land to water analysis for 2002 indicates 45 acres of open water and 149 acres of land in the project area (figure 3). Aerial photography taken in 1993 was used as a baseline for shoreline position instead of the actual DGPS shoreline positions captured in 1995. This was three years prior to construction of the Vermilion River Cutoff Bank Protection (TV-03) project in February 1996, which increases the probability of error in interpreting actual land to water acreages. The data used for the shoreline analysis was from DGPS acquired by USGS and LDNR personnel. Analysis of baseline DGPS taken in 1997 was compared to DGPS taken in 1999, 2002, and 2006. The results of a shoreline analysis from 1997 and 2006 shorelines are mapped in figure 4. Change rates were calculated in m/yr for the length of the project area along transects spaced 20 m apart. Resulting change rates were determined and averaged from each transect along the shoreline. The rate of change for the project area behind the rock for the period of record November 1997 to July 2006 is an average loss of -0.24 m/yr. The results of the analysis from 2002 to 2006 DGPS are mapped in figure 5. The rate of change for the project area is an average gain of 0.27 m/yr.

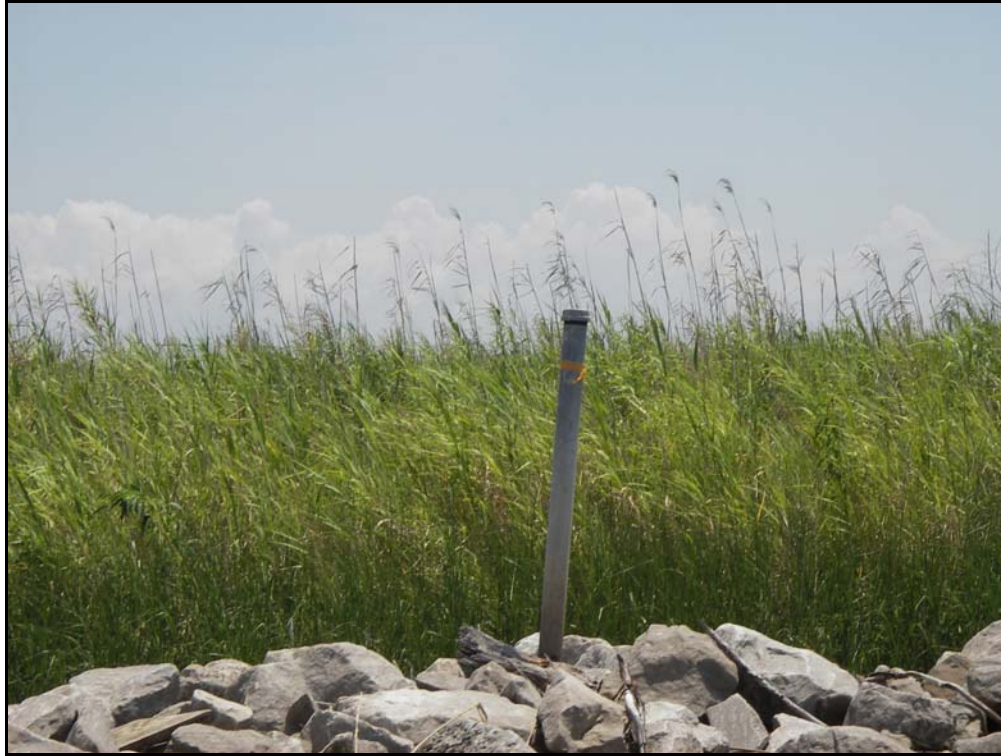
Figure 6. Settlement plate 1007 in the Vermilion River Cutoff Bank Protection (TV-03) project at the southern end of the rock breakwater.

Direct shoreline measurements taken from each settlement plate (figure 6) to the vegetated edge of the marsh behind the rock breakwater in the project area indicate progradation at four of the five sites. Only one site, at settlement plate 1006, experienced a loss of approximately 0.1 m/yr (table 1). Settlement plates 1003 and 1004 showed a gain of 0.9 m/yr and settlement plates 1005 and 1007 had a gain of 0.5 and 0.1 m/yr, respectively. The data from these measurements indicate the shoreline behind the rock breakwater on the three northernmost and the southernmost settlement plates are prograding. The loss of shoreline behind settlement plate 1006 may be attributed to the sinking elevation of the rock breakwater at or below 2 ft NAVD 88.

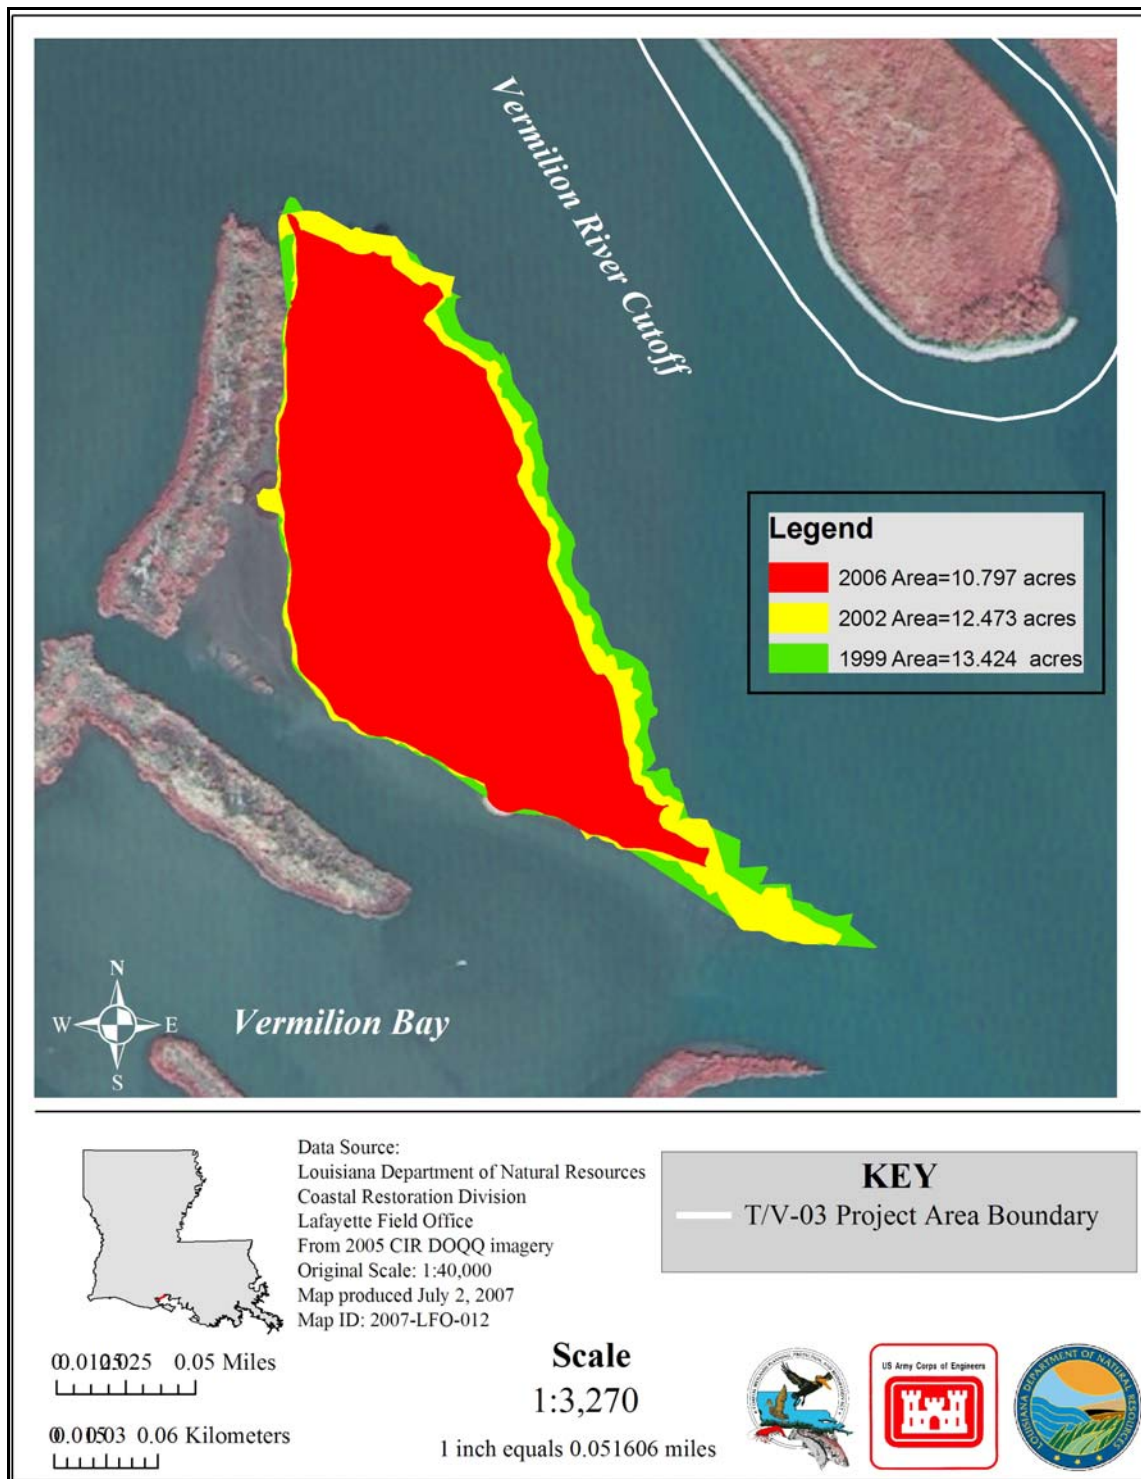
Figure 7. Land change map of an island located across from the Vermilion River Cutoff Bank Protection (TV-03) project area.

In 1999, 2002, and 2006, ancillary DGPS data were collected along the west bank of the Vermilion River Cutoff Bank Protection project and surrounding the island (figure 7). The DGPS line data were converted to a closed polygon feature and acreages were calculated. Acreage in 1999 was 13.42 and in 2002 the area was 12.47 ac, indicating a loss of 0.95 ac. Area in 2006 was 10.8 ac, indicating a loss of 1.68 ac from year 2002 and a total loss of 2.63 ac since 1999. The rate of change for all data collected from 1999 to 2006 indicated a loss of 0.37 ac/yr.

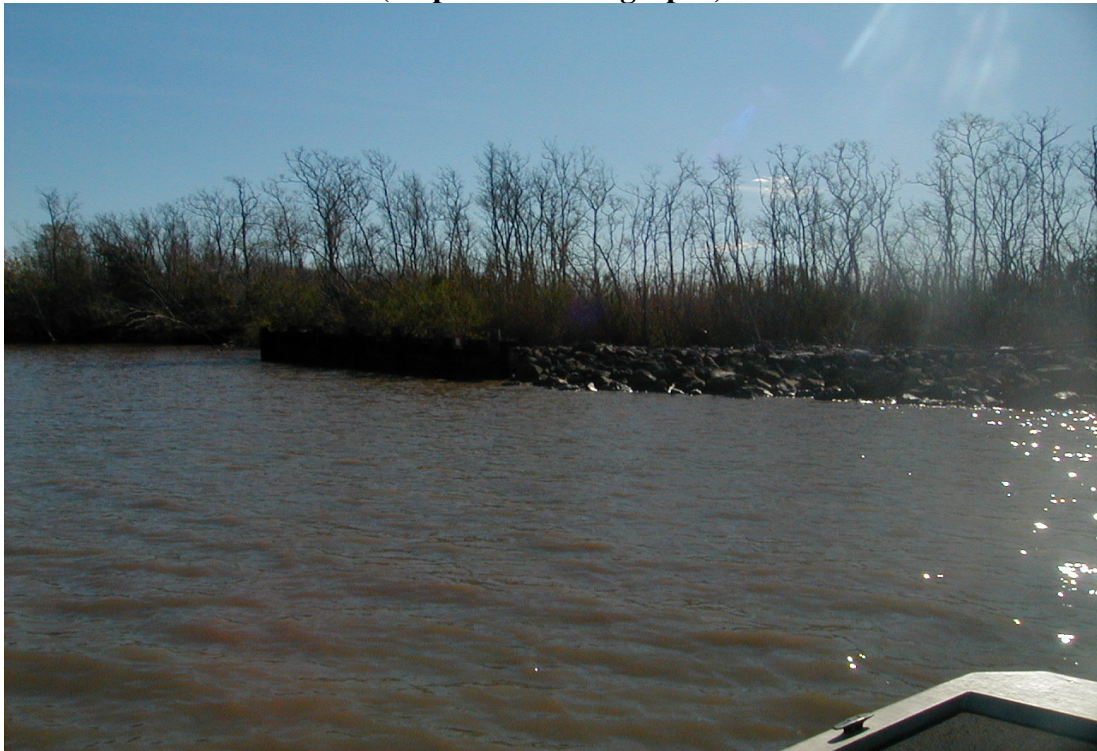
Photo 1—north tie-in

The foreshore dike is in excellent condition with no maintenance required or foreseen. (Photos: Appendix B, Photos 1 and 2).
